BULGARIAN FIGHTER COLOURS 1919–1948

Vol. 1

Rainbow No 9136

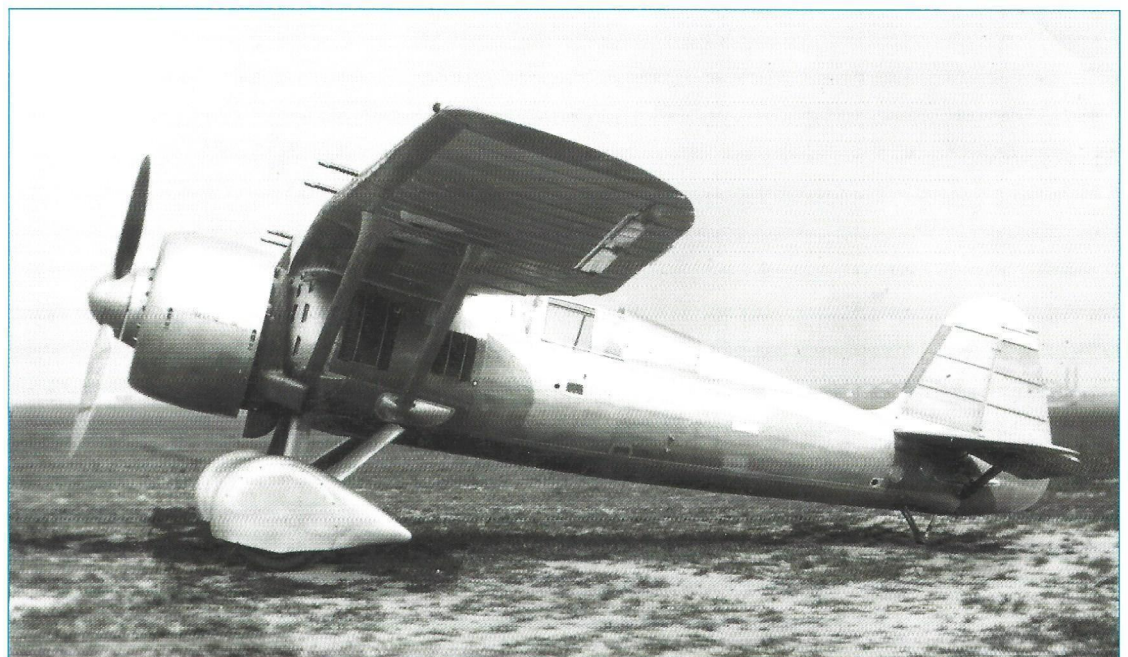
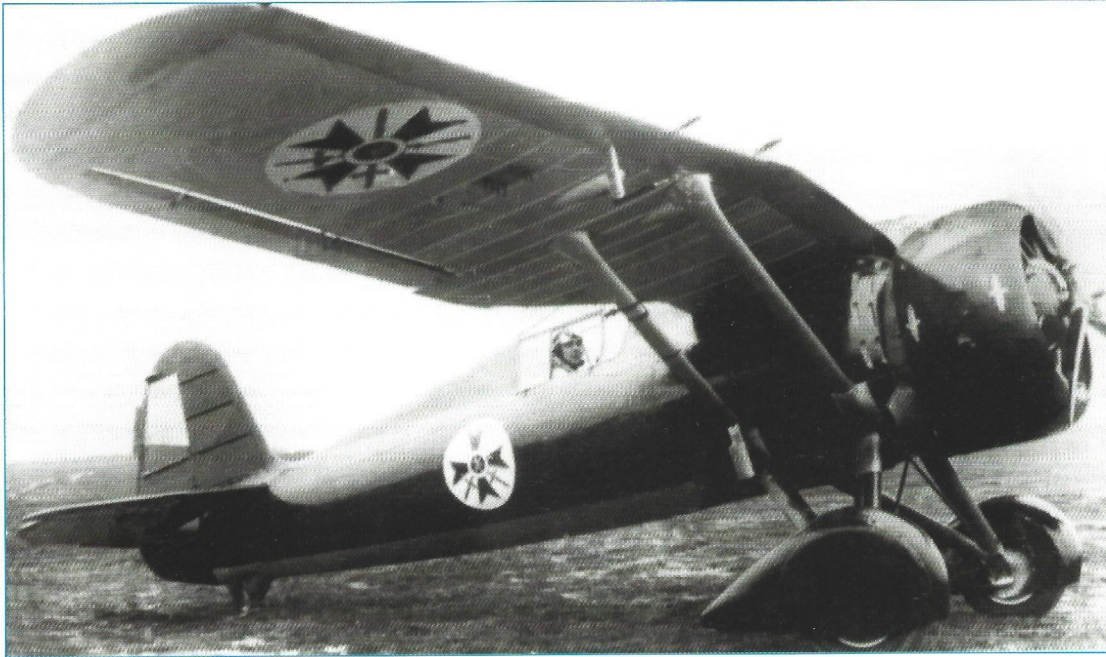
One of the first PZL P.24bs seen during acceptance trials at PZL's Okęcie factory airfield, Poland, in late 1936. Note the Bulgarian tricolour segments are painted with slanted edges. The fuselage flash is missing. The quick-release locks on the engine cowling side are unpainted. The golden rampant lion doesn't seem to be applied to the centre of the wing marking. All these errors were corrected by the time the aircraft entered active service with the VNV in the Spring of 1937.

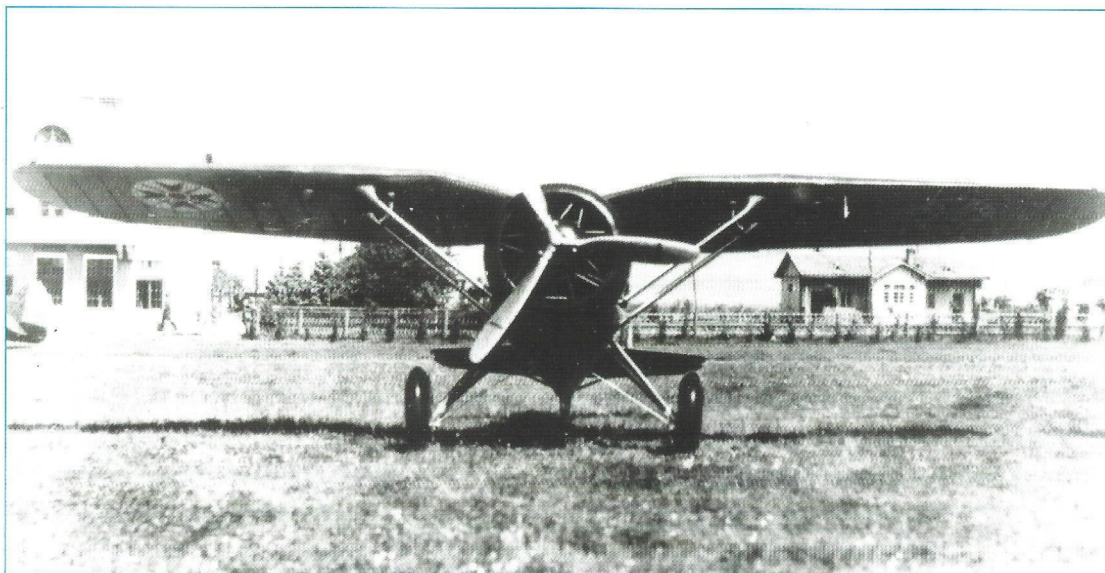
Frontal view of one of the freshly delivered PZL gull-wing fighters. Notice the unequal width coloured stripes painted on the rudder of the unidentified aircraft type, at left.

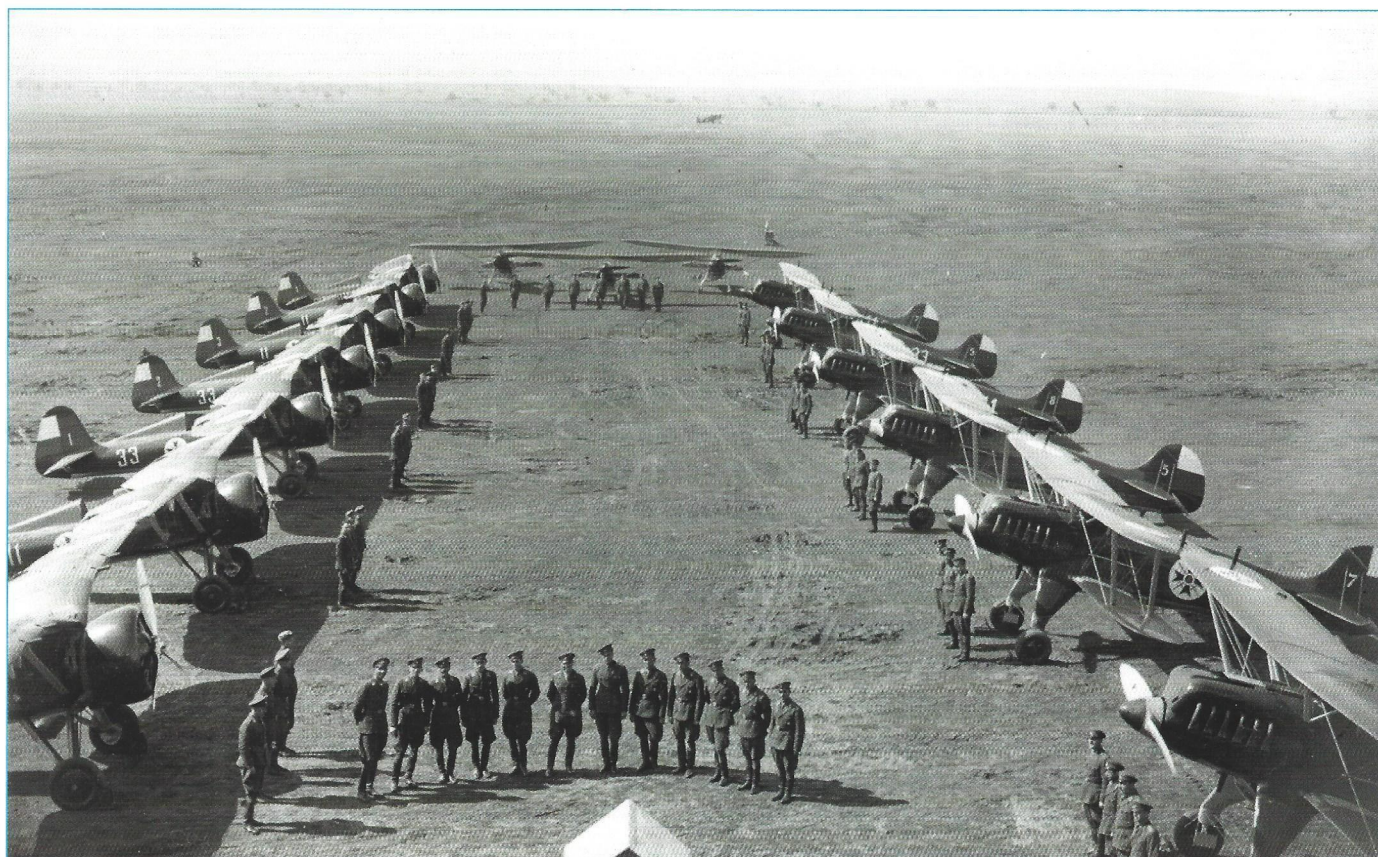
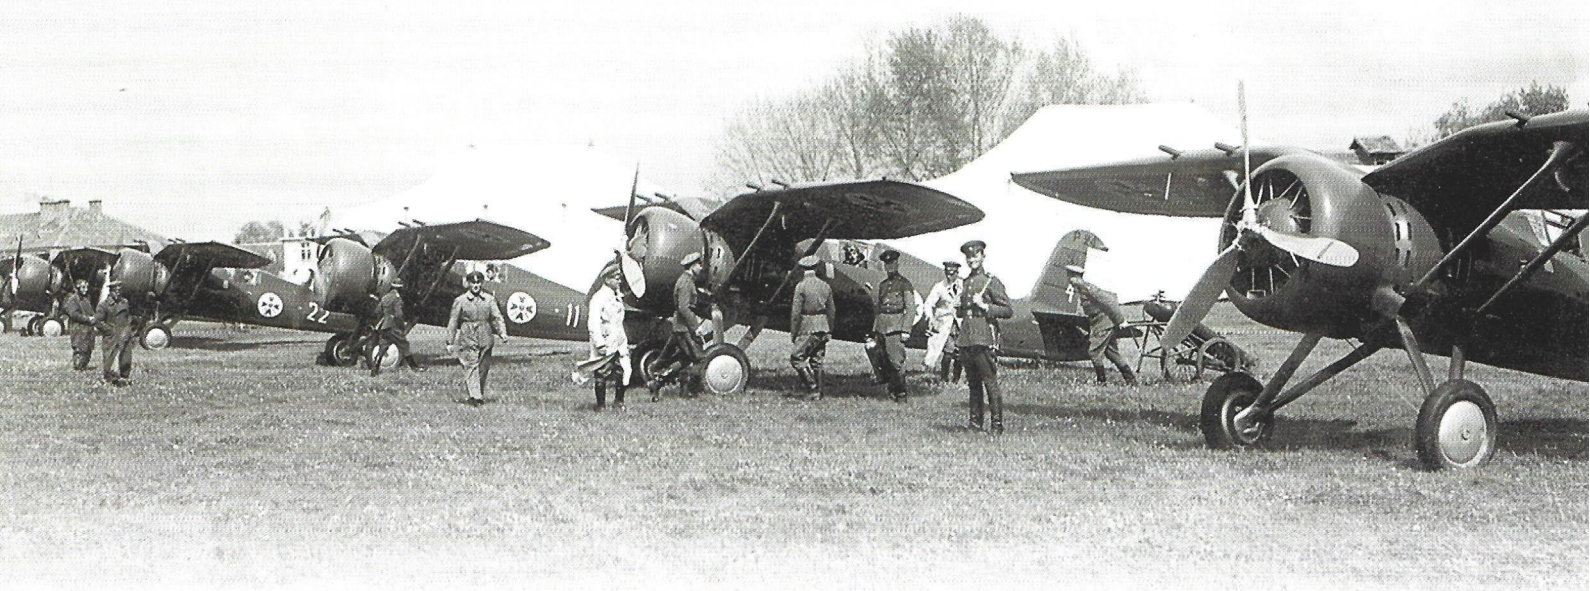
Busy day at a temporary landing ground, during manoeuvres (notice the army tents in the background), sometime in autumn 1937. Notice the wheel covers are light grey (metal), in contrast to khaki camouflage colour, as seen on other photos.

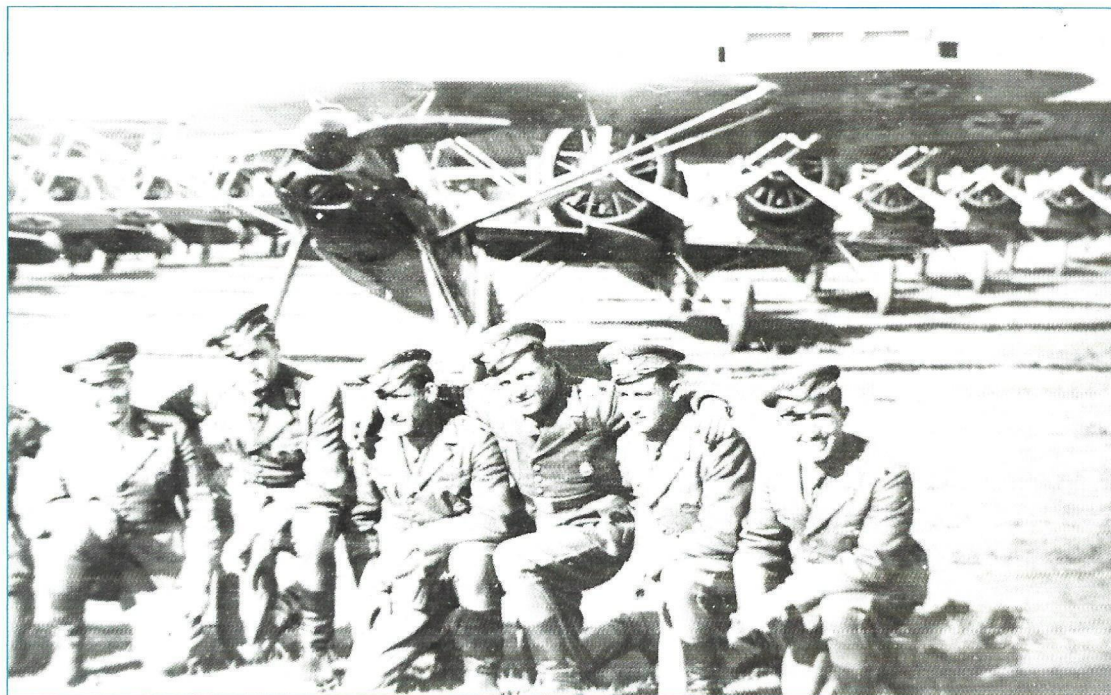
Another group of Bulgarian pilots, this time clad in flying overalls, complete with goggles, pose in front of a P.24b. The aircraft's pilot, seated in the cockpit, warms up the engine prior to take-off for a training sortie, sometime in the late 1930s. Notice the four wing-mounted 7.9 mm calibre Colt-Browning MG 40 machine guns, protruding from the wings' leading edge.

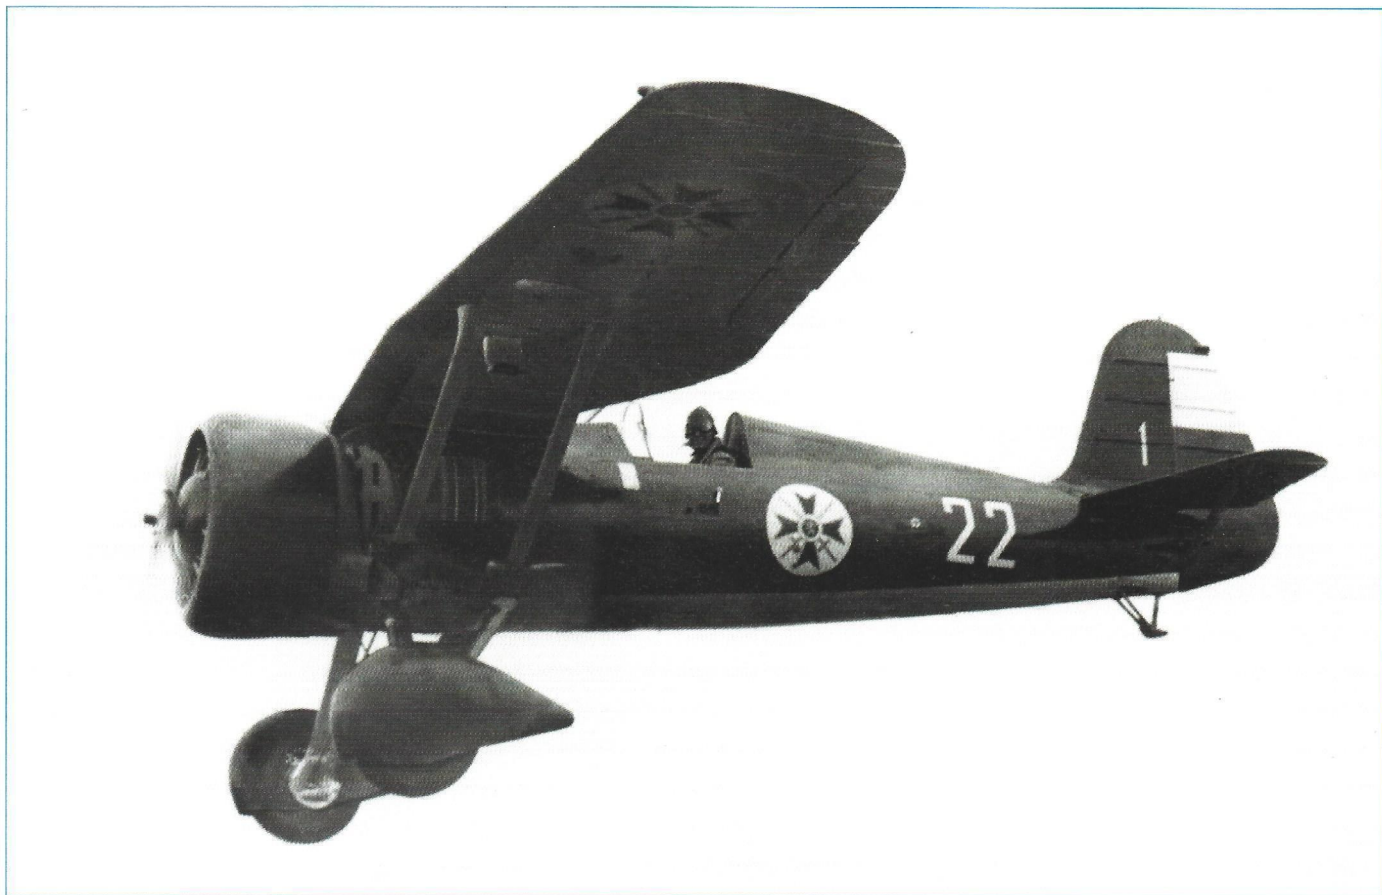
The elegant silhouette of the gull-wing PZL P.24 is shown in its splendour, in the element she belongs to: the air. The machine guns had been removed, as was the cockpit canopy – a common occurrence during training flights.

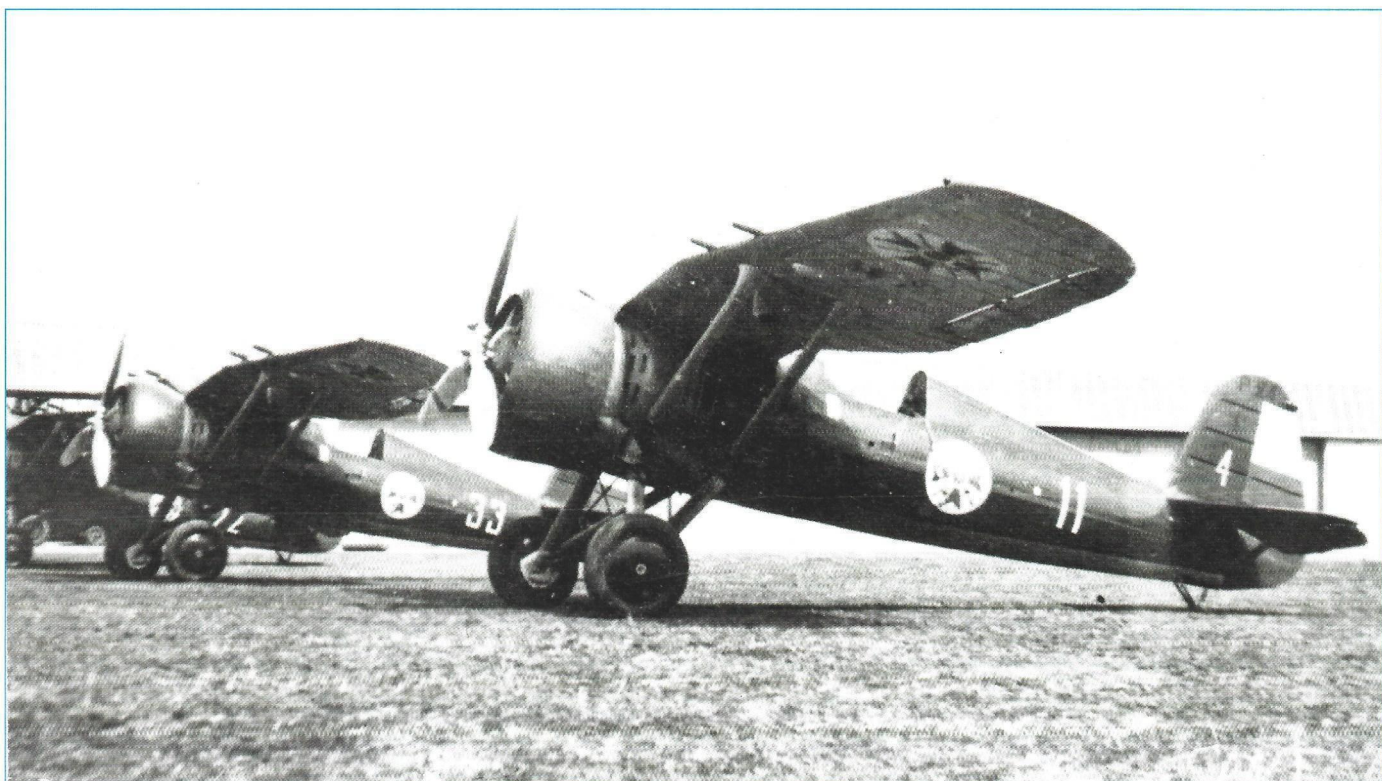
The elegance of the Polish-designed aircraft type was equally obvious on the ground. The cockpit canopy is again missing; however, the machine guns are in place. Notice the red factory emblem and aircraft type stencilled onto the top fin. A German document dated 1 June 1940 lists eleven extant PZL P.24s and categorises the fighter type as '1st Class' (the same category as the Bf 109E).

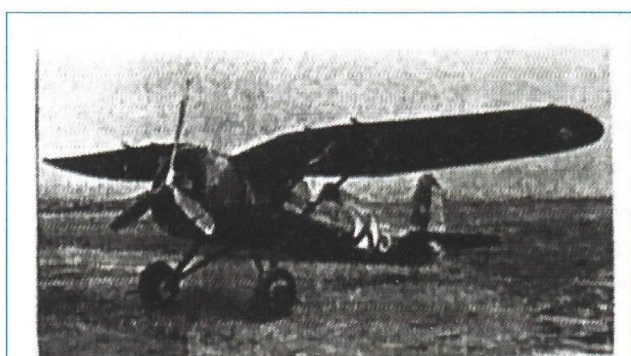
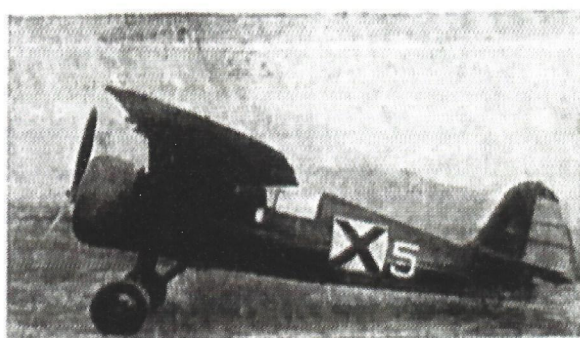
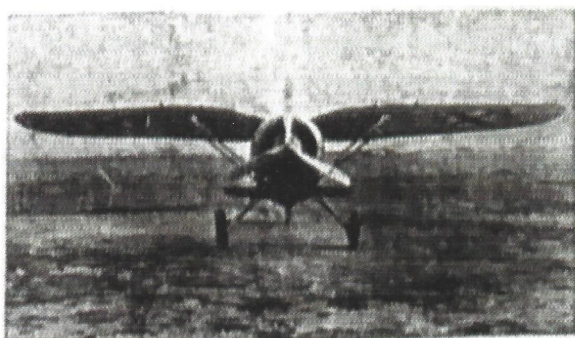
ЯСТРЕБЪ

Below, left: This page of an official Bulgarian aircraft silhouette recognition manual, scanned at the Bulgarian military archives at Veliko Tărnovo, shows the PZL P.24b, identified by its official air force code name *ястреб* (i.e. Yastreb). The depicted sample aircraft already sports the Axis style 'black St. Andrew's cross in white square' type military marking.

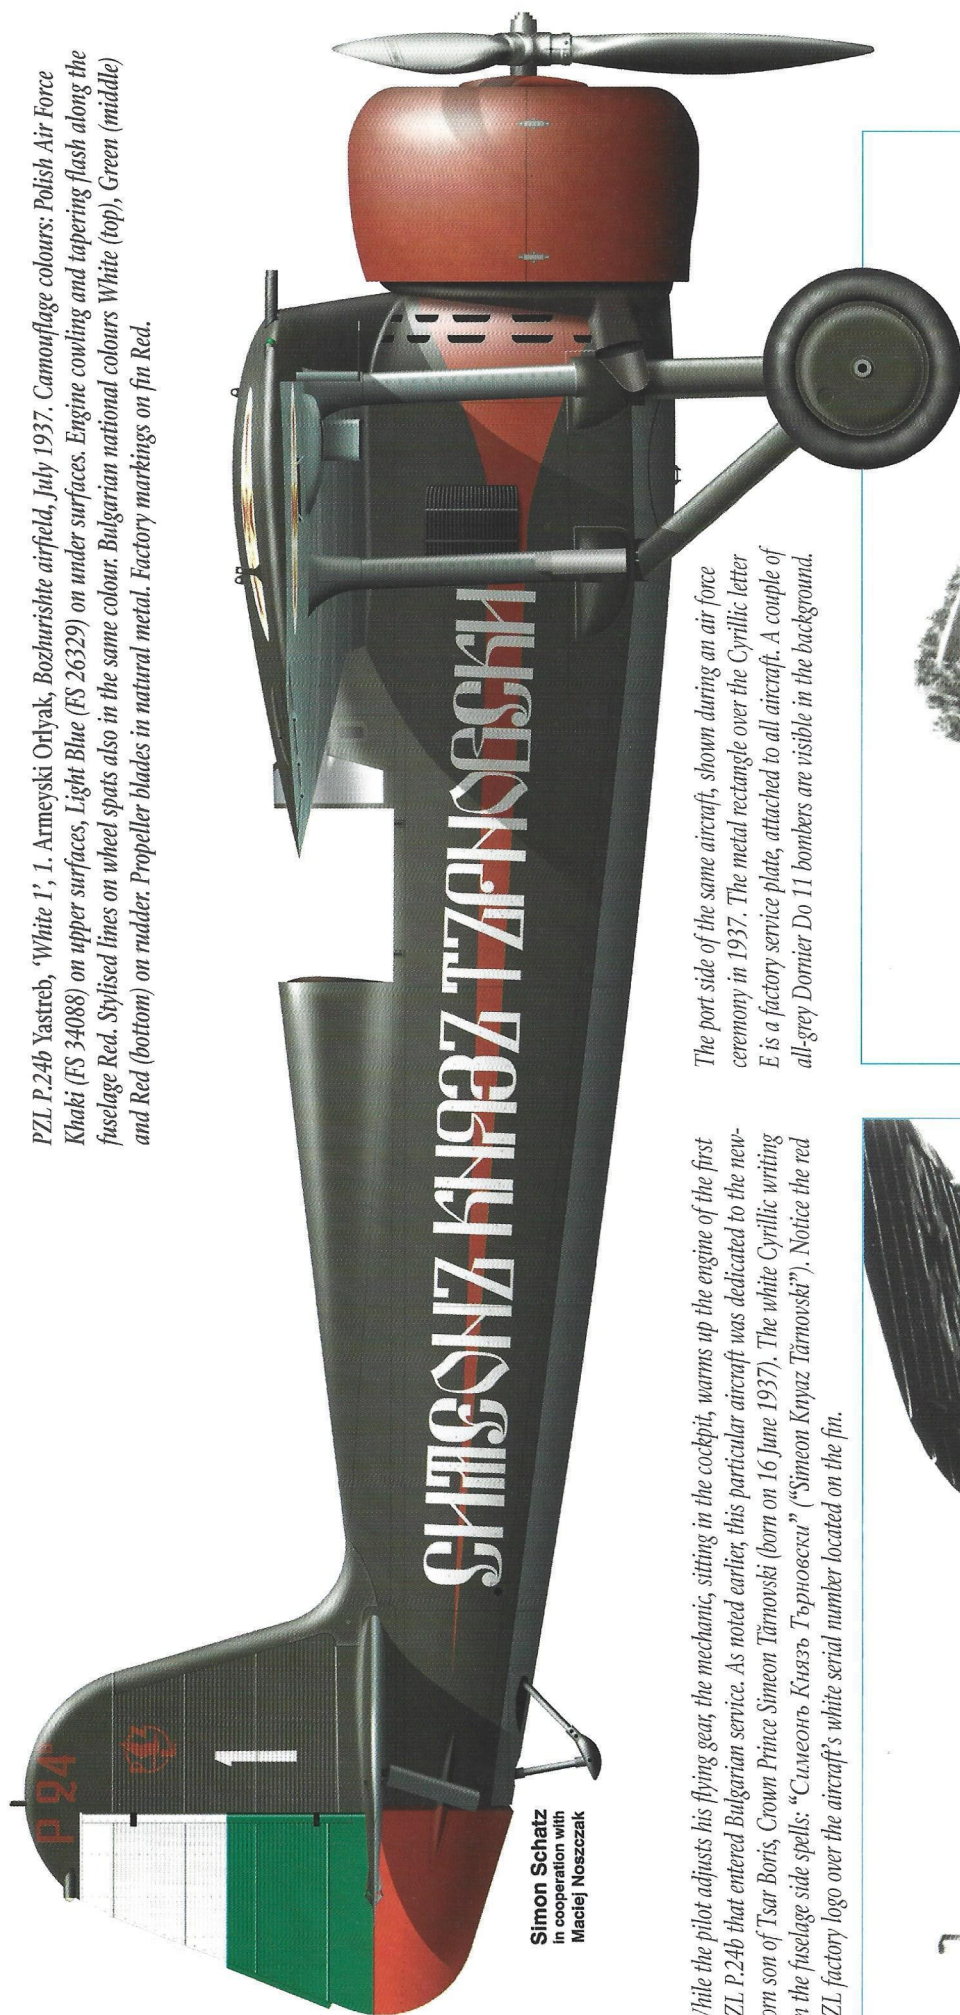
PZL P.24b Yastreb, 'White 1', I. Arneyski Orlyak, Bozhurishite airfield, July 1937. Camouflage colours: Polish Air Force Khaki (FS 34088) on upper surfaces, Light Blue (FS 26329) on under surfaces. Engine cowl and tapering flash along the fuselage Red. Stylised lines on wheel spats also in the same colour. Bulgarian national colours White (top), Green (middle) and Red (bottom) on rudder. Propeller blades in natural metal. Factory markings on fin Red.

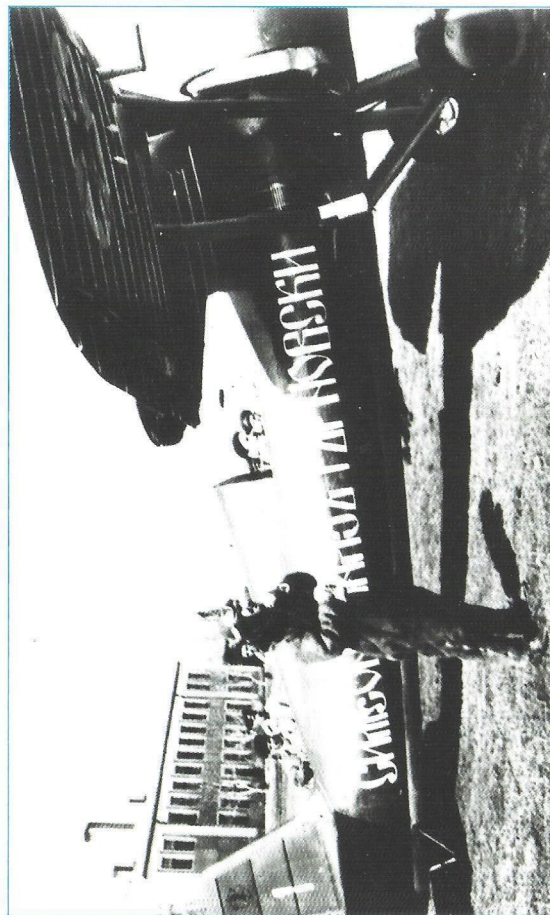
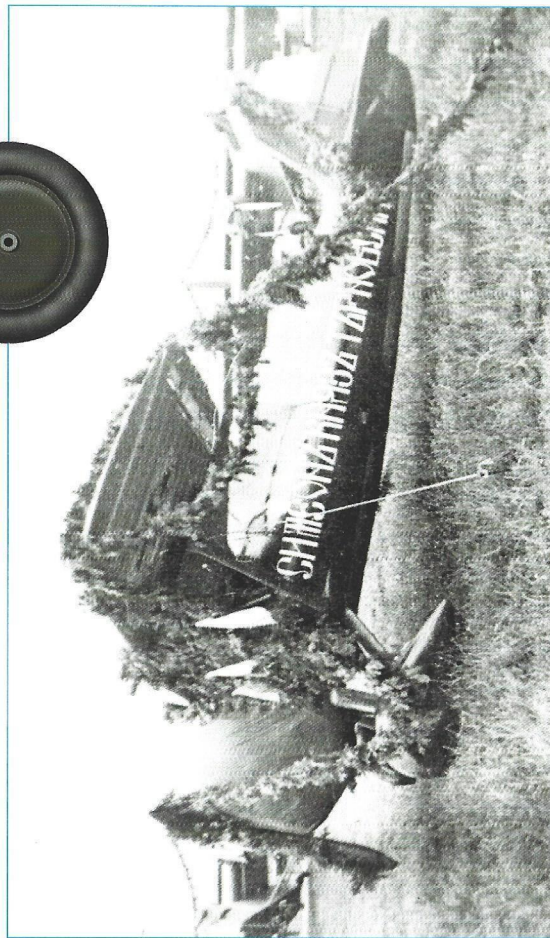
PZL P.24b Yastreb, 'White 11-2', 902. Yato, pilot: Podporuchik Viktor Evstatiev Pavlov, Bozhurishite airfield, June 1940. Camouflage colours: Polish Air Force Khaki on upper surfaces, Light Blue on under surfaces. Engine cowling and tapering flash along the fuselage Red. Stylised lines on wheel spats also in the same colour. Bulgarian national colours White (top), Green (middle) and Red (bottom) on rudder. Propeller blades in natural metal. Factory markings on fin Red.

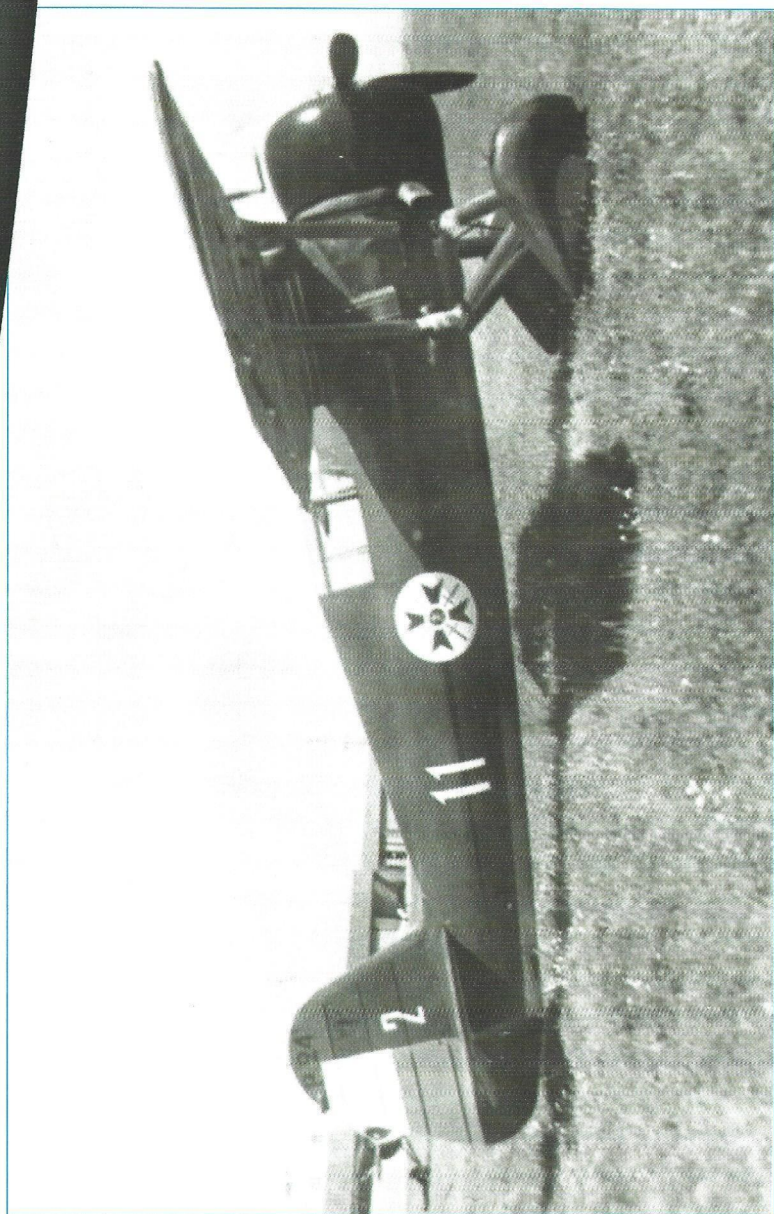
The elegant silhouette of the PZL P.24 is nicely shown in this perfect side view photo. The aircraft wore typical Polish camouflage colours of khaki on the upper surfaces, over light blue. The engine cowling and the tapering red flash along the fuselage side were blood red. Following the deadly in-flight accident of Poruchik Vasil M. Benchev, who reportedly suffocated in the aircraft's cockpit following an engine fire in June 1938, the centre window of the cockpit canopy was removed on all aircraft.

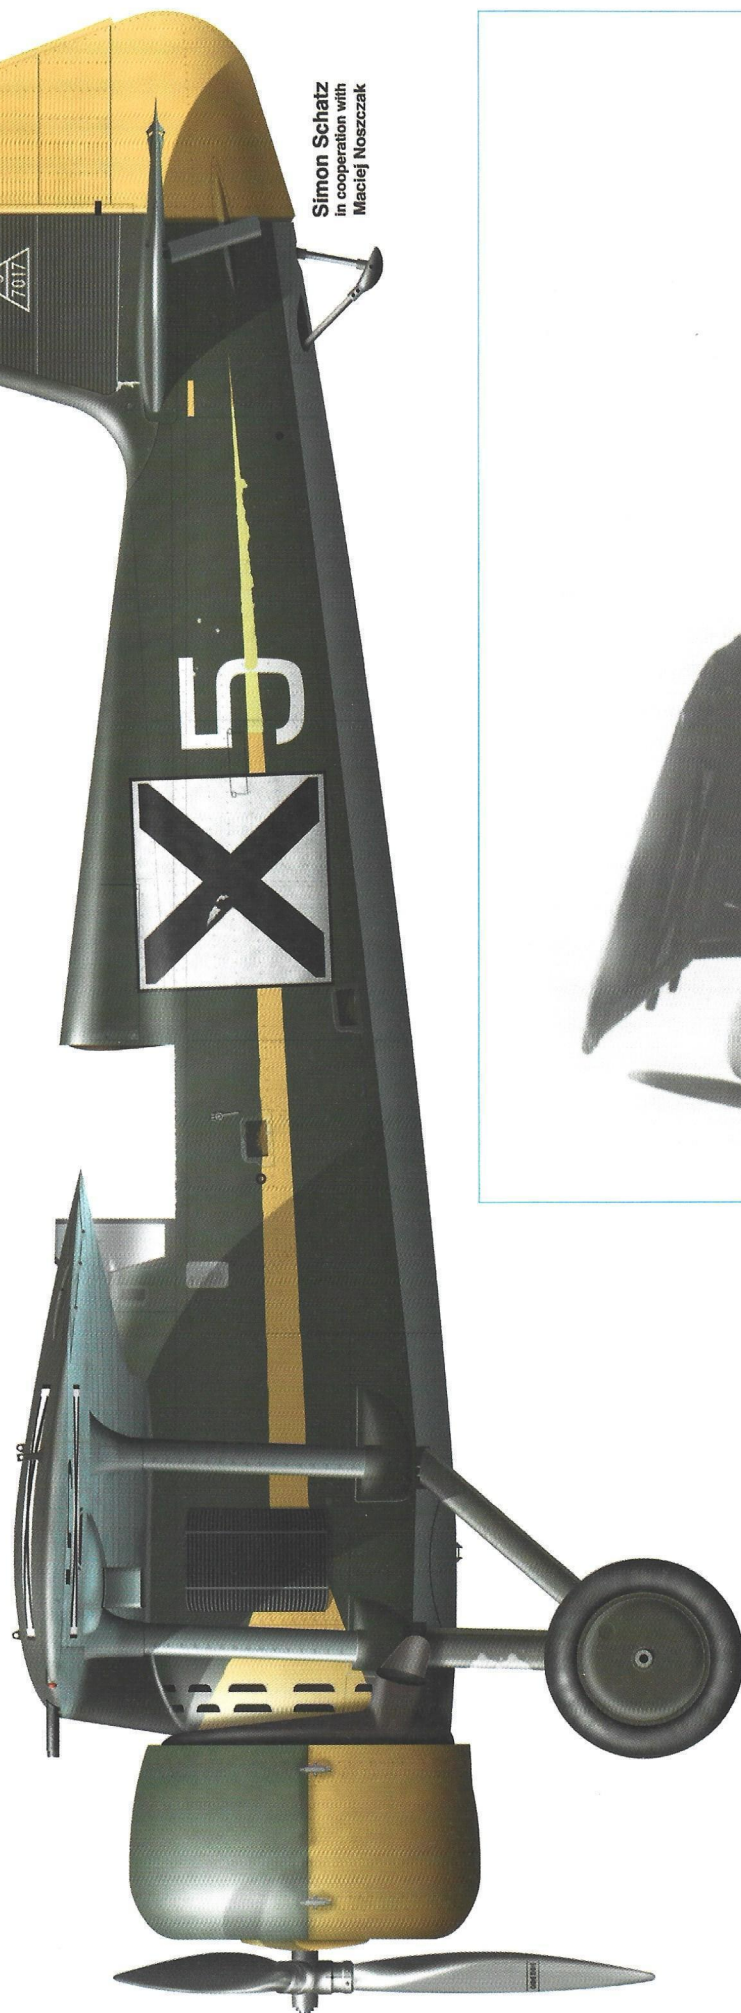
PZL P.24b Yastreb, 'White 5' (5/7017), 1/6. Orlyak, 6. Iztrebitelet Polk, Asen airfield, April 1941. Camouflage colours: Polish Air Force Khaki on upper surfaces, Light Blue on under surfaces. Lower engine cowl and tapering flash along the fuselage Yellow. Rudder in the same colour. Propeller blades in natural metal. Factory markings on fin Red.

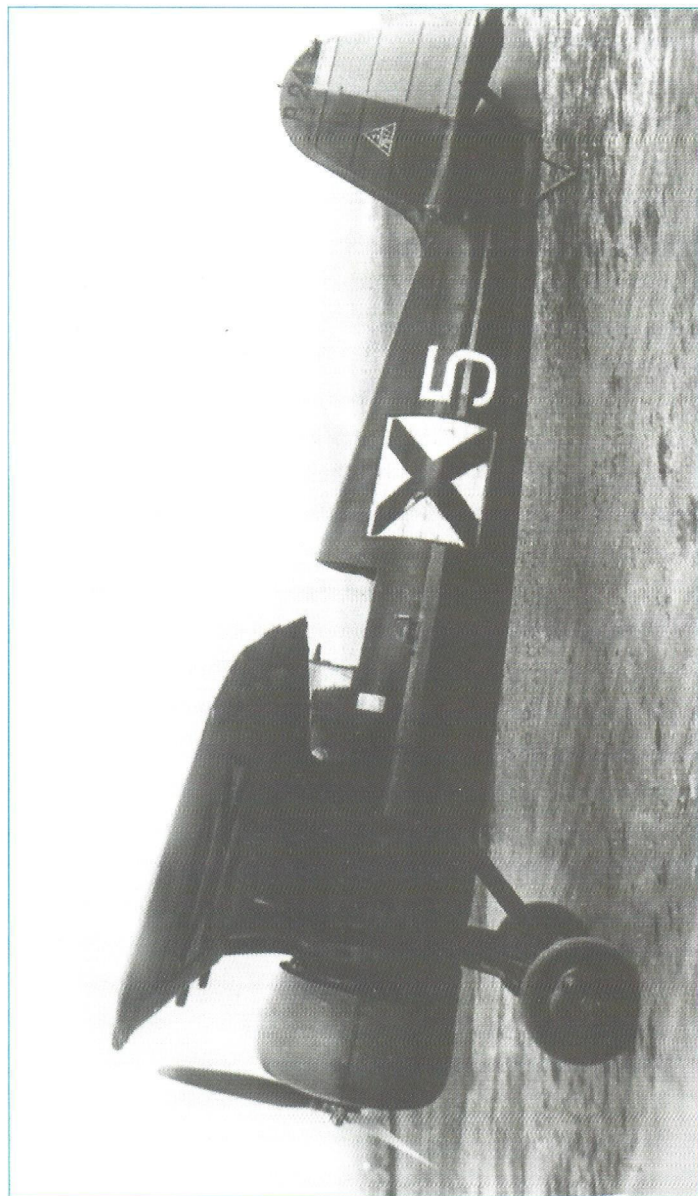
This is the only known P.24b showing the entire aircraft and all codes that was photographed wearing the pro-Axis military markings. Luckily for the artist, this nice profile view allows all details to be properly represented in the artwork. The lower engine cowl and the tapered flash along the fuselage, as well as the rudder, were yellow. Note the typical VNW triangle applied on the fin, which identifies the fighter type's Nomenklaturen Nomer (Register Number) as 7017, meaning that it was the second fighter aircraft type in Bulgarian service (the first one, No. 7007, was the Heinkel He 51).

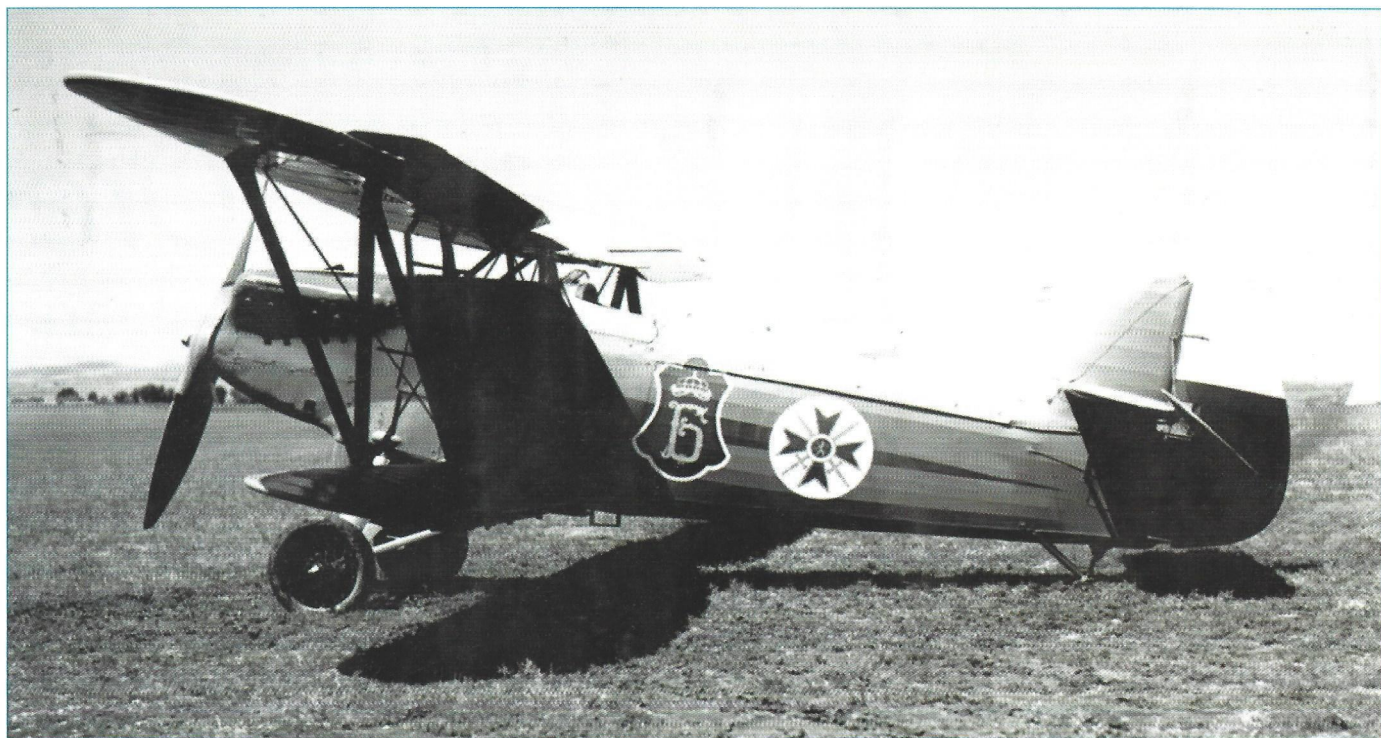
One of the first Arado Ar 65Fs to be assembled and painted in full Bulgarian combat livery, as well as military markings, seen in mid-1937. No serial number was assigned yet to this particular machine. The aircraft type is also missing from the mid-fin.

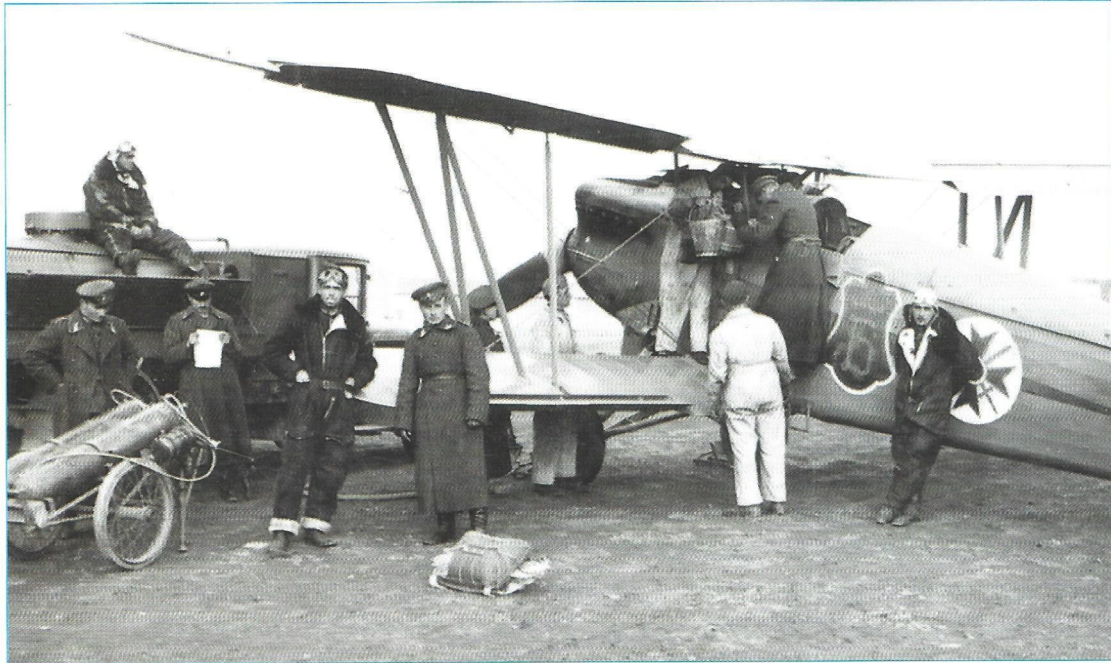
Orel No. 110 and its pilot are prepared for a morning training flight. Interestingly, the last digit (0) is missing from the rudder. One possible explanation is that it's a replacement rudder, and there was no time, or will, to repaint the number 0.

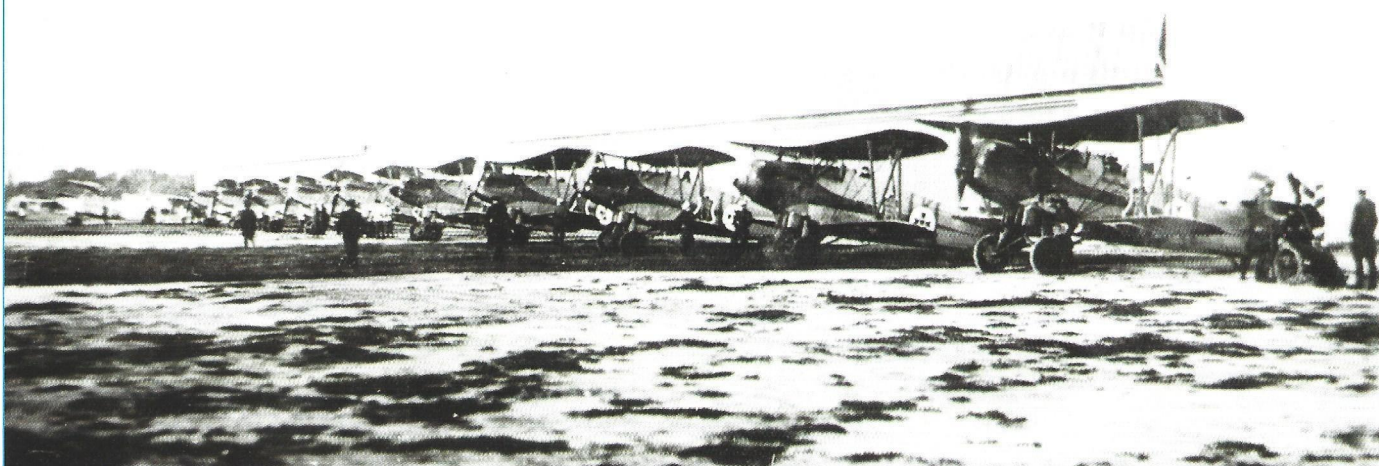
Ten Arado Ar 65s are lined up in front of one of Karlovo's hangars, during late 1939. The eleventh one (at far left) is taxiing towards the runway. The twelfth one had crashed in September and would be written off.

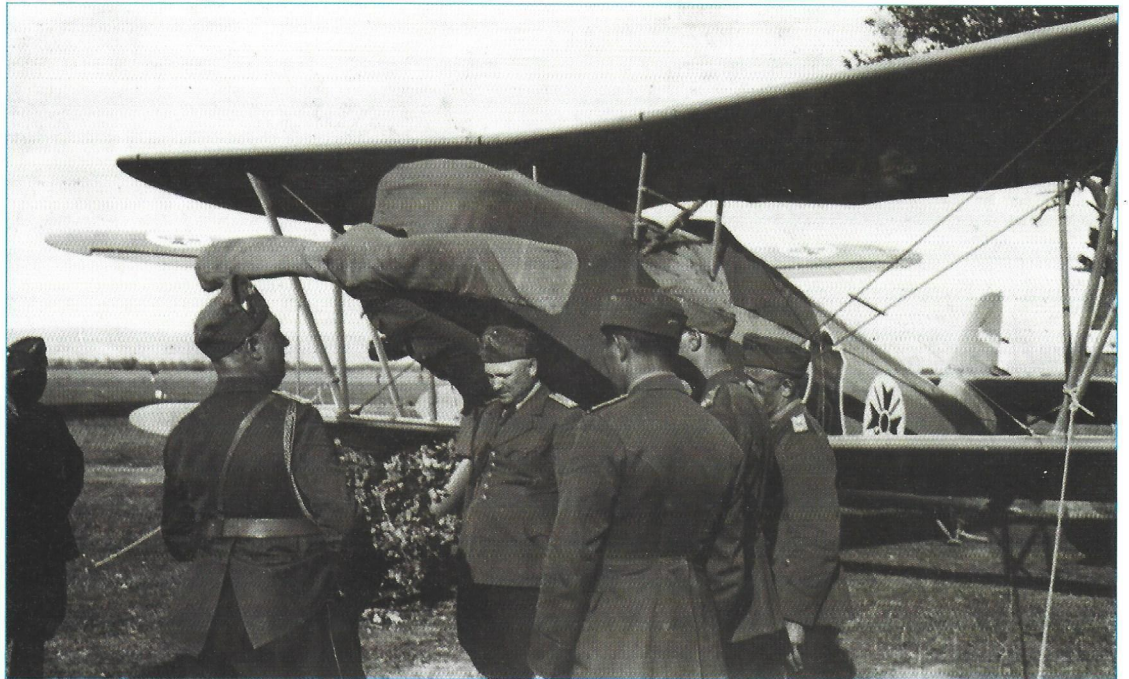
The broken propeller and damaged port lower wing leading edge point to a minor accident that may have occurred when the port wheel struck a hard object, or pothole, during low speed taxiing, pushing the airframe on its nose, leaning towards left.

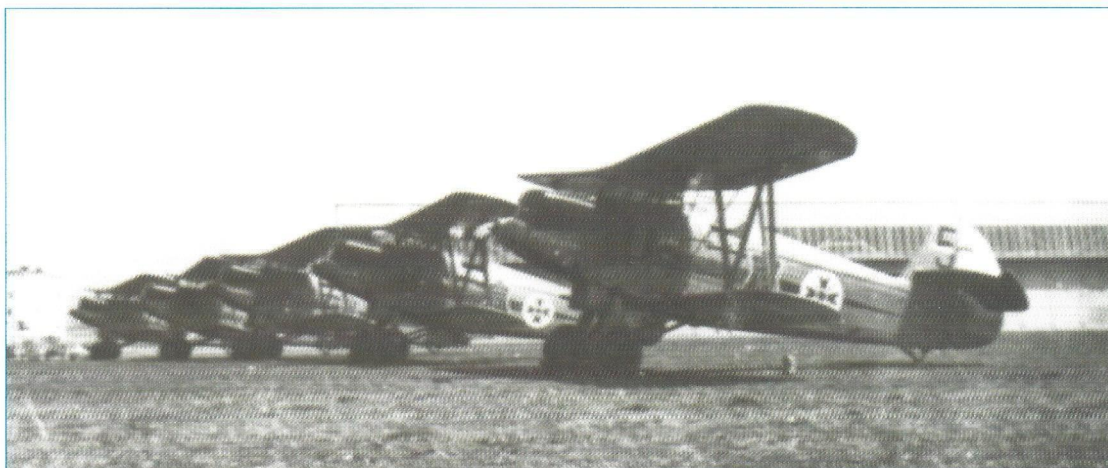
Based on an official decree dated 14 April 1938, the last digit(s) of the individual serial number was painted in large black numeral on the fin, so the aircraft could be identified from a distance. This feature can be observed on these machines lined up on Marno Pole/Karlovo main air base.

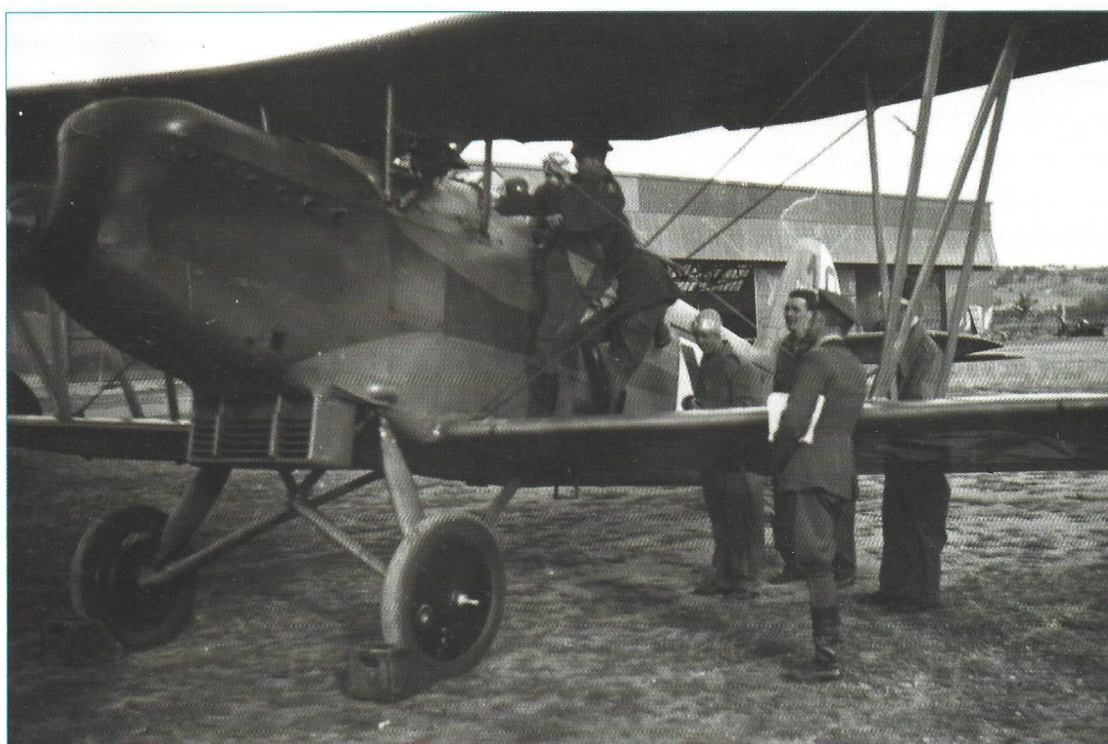
In late June 1940, the so-called 'Tsarist Roundel' type military marking was replaced by the 'St. Andrew Cross' type one, consisting of a black X in a white square. The new marking was also applied in six positions, usually directly over the previous one. This (partial) overlapping of the new/old markings can be clearly observed on the lower surface of the lower wing of Orel No. 10. All other identification symbols stayed unaltered – for a while.

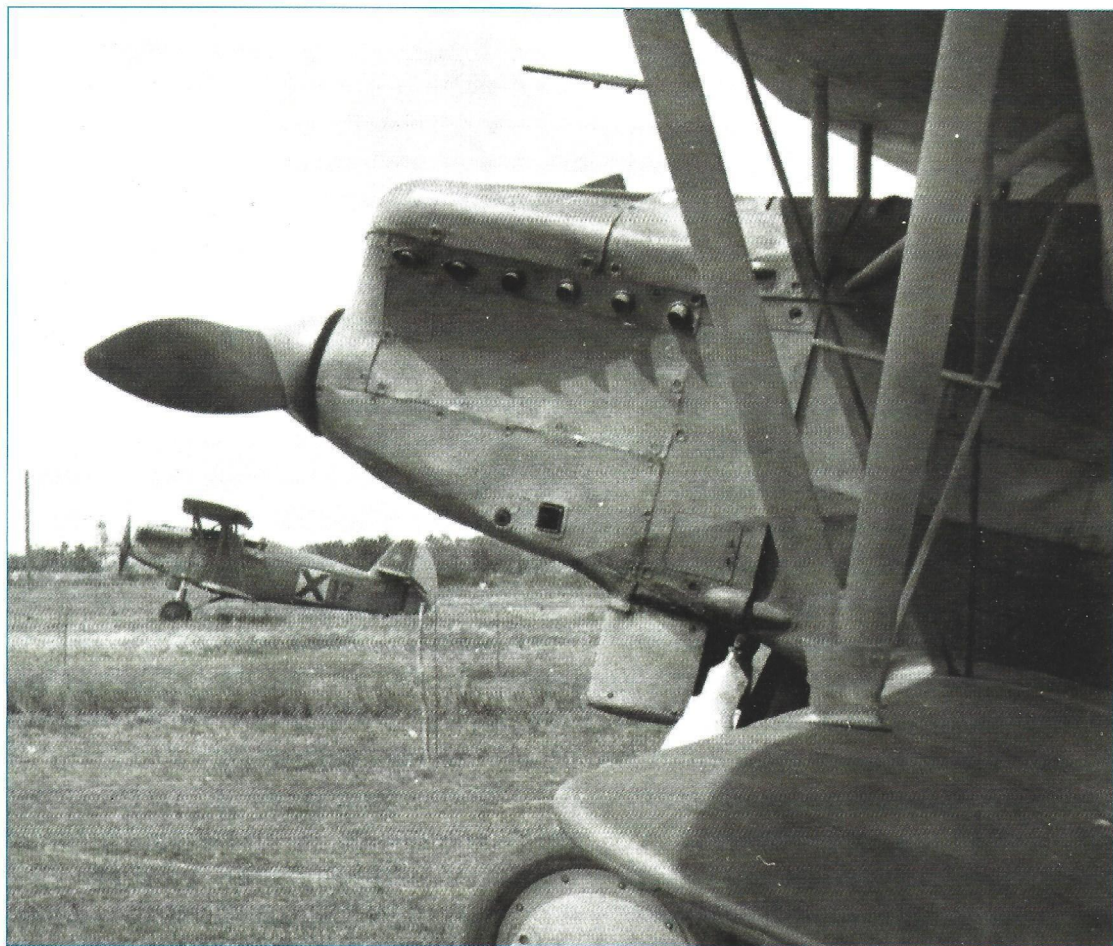
The large, black numerals written on the tail surface, the red nose and the 'St. Andrew Cross'-style military marking date the photo from the spring of 1938 up to about mid-1941. Aircraft Nos. 11, 12, 9 and 4 are lined up on Marno Pole/Karlovo main air base.

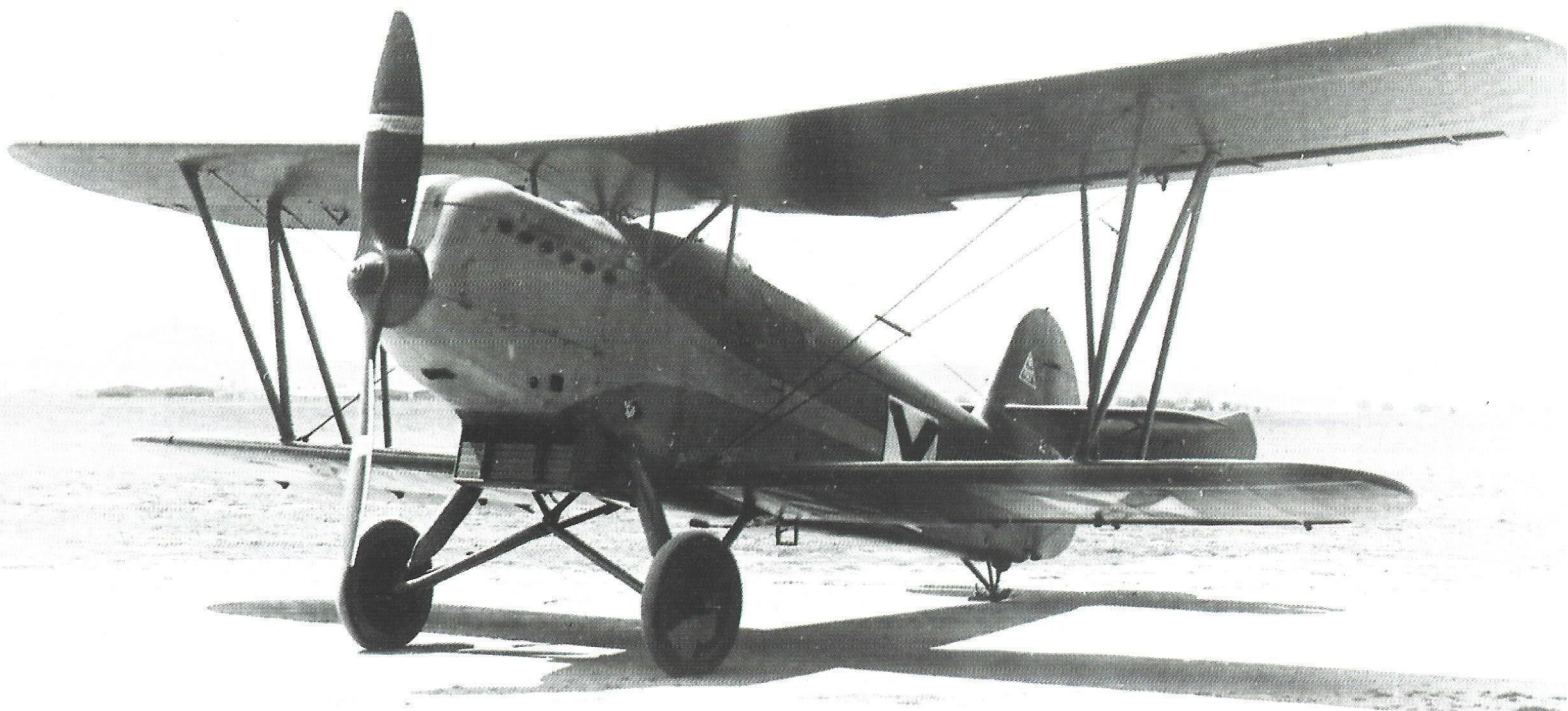
Sometime in the Summer of 1941, the white aircraft type and large black serial number disappeared from the fin (and rudder), the peculiar Bulgarian triangle being applied instead on mid-fin. The Bulgarian tricolour on the rudder was overpainted in grey, as was the 'royal cipher', most probably to reduce visibility. Soon after, the surviving aircraft were repainted in Dark Green on their upper surfaces, over the original Light Grey, during their scheduled overhaul, or unscheduled repair work. The wraparound engine cowling, along with the rearward tapering flash along the fuselage, was repainted yellow instead of red. This is the livery used by the last serviceable Arado Ar 65Fs until they were scrapped in 1944/1945.
